DEPARTMENT OF TRANSPORTATION**DIVISION OF ENGINEERING SERVICES**

Contract #: 04-0120F4Cty: SF/ALA Rte: 80 PM: 13.2/13.9File #: 69.28**WELDING INSPECTION REPORT****Resident Engineer:** Pursell, Gary**Address:** 333 Burma Road**City:** Oakland, CA 94607**Report No:** WIR-001685**Date Inspected:** 04-Mar-2008**Project Name:** SAS Superstructure**OSM Arrival Time:** 1800**Prime Contractor:** American Bridge/Fluor Enterprises, a JV**OSM Departure Time:** 530**Contractor:** Zhenhua Port Machinery Company, Ltd (ZPMC), Changxing Island **Location:** Shanghai, China**CWI Name:** Li Zhi Jiang**CWI Present:** Yes No**Inspected CWI report:** Yes No N/A**Rod Oven in Use:** Yes No N/A**Electrode to specification:** Yes No N/A**Weld Procedures Followed:** Yes No N/A**Qualified Welders:** Yes No N/A**Verified Joint Fit-up:** Yes No N/A**Approved Drawings:** Yes No N/A**Approved WPS:** Yes No N/A**Delayed / Cancelled:** Yes No N/A**Bridge No:** 34-0006**Component:** OBG**Summary of Items Observed:**

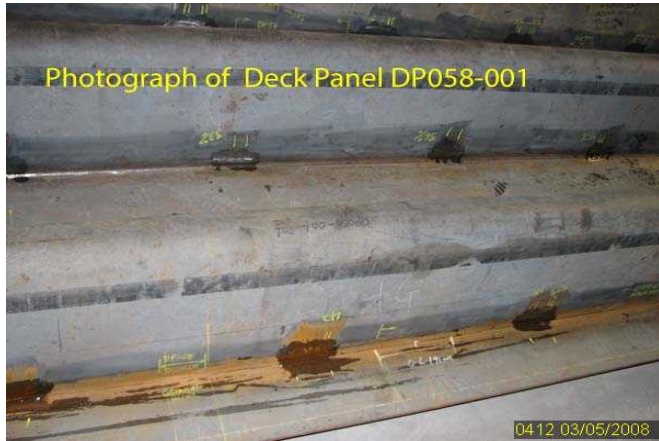
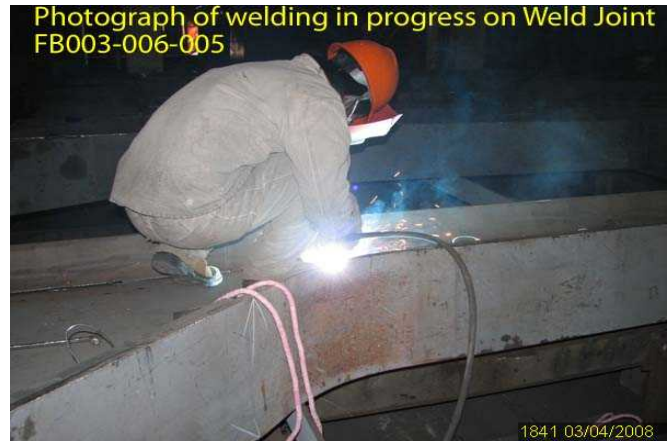
Bay 7- QA Inspector randomly observed ZPMC qualified welder Wang Linjiang Identification (ID) #051356, utilizing the Flux Core Arc Welding (FCAW) process per the approved Welding Procedure Specification (WPS) WPS-B-T-2132-3 while performing welding on Floor Beams FB003-006 at weld joint FB003-006-005. The QA Inspector observed ZPMC Certified Weld Inspector (CWI) Li Zhi Jiang monitoring welding and preheating parameters. The QA Inspector also randomly monitored weld parameters and recorded them as follows: welding amperage 303 amps, welding voltage 29.4 volts. The weld parameters appeared to comply with contract requirements and the approved WPS.

OBG Yard- Caltrans QA Inspector performed an Ultrasonic Test (UT) inspection of the partial joint penetration (PJP) welds between the closed u-ribs and deck panel of DP058-001. UT inspection was performed at 100% of the tack welded locations on welds DP058-001-001, DP058-001-002 and DP058-001-005. QA Inspector observed that the tack welded locations of welds DP058-001-006 thru DP058-001-010 were UT inspected by Caltrans QA Inspector Alfredo Acuna and welds DP058-001-003 and DP001-004 were inspected by Caltrans QA Inspector Greg Bertlesman. QA Inspector recorded the results of the inspection and generated an ultrasonic test report. See ultrasonic testing report TL-6027 Modified dated March 04, 2008 for more details.
